Historic Preservation & Energy Efficiency

A GUIDE FOR HISTORIC COMMERCIAL BUILDINGS

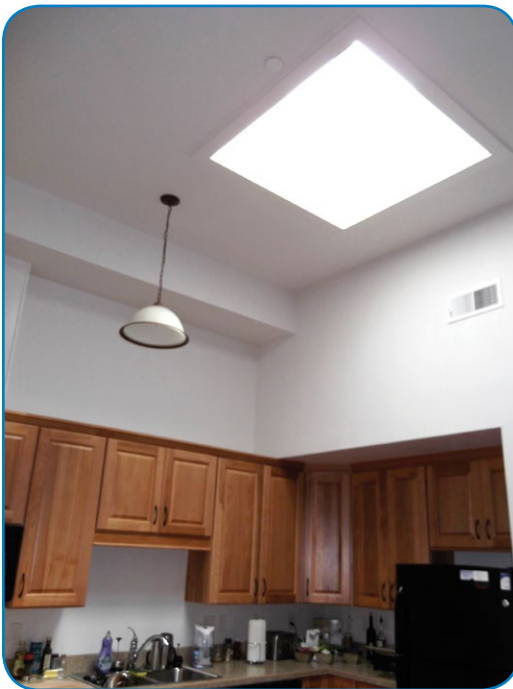
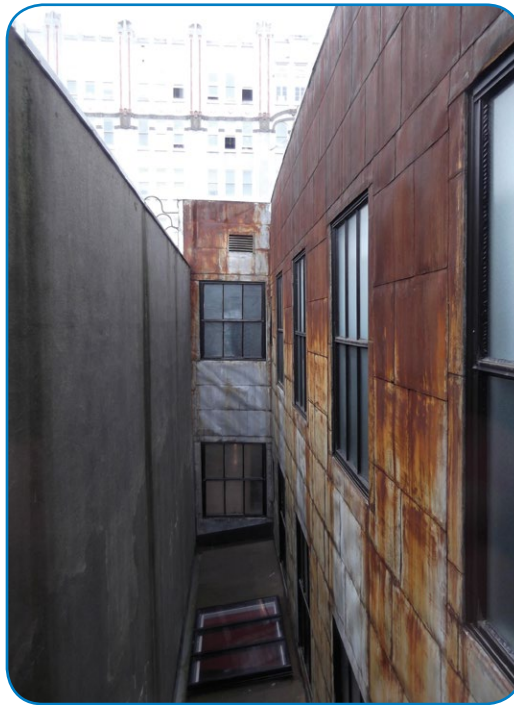
Skylights add natural light to those spaces not reached by the storefront or transom windows. When found on second or upper story spaces, skylights are frequently used in hallways. Historically, skylights were equipped with vents to pull hot air from ceiling levels.

Light wells are open, unroofed areas found between the wings of U-shaped buildings or the centers of donut-shaped buildings. Their operable windows bring both natural light and ventilation into rooms not accessible from the primary elevations.

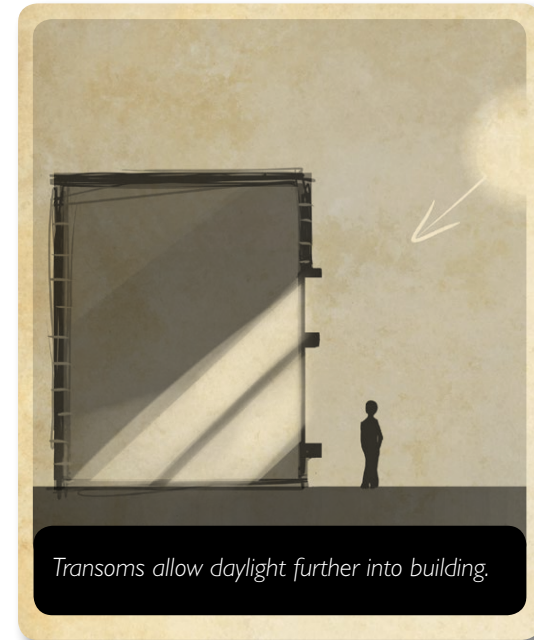
Transoms allow daylight further into building.

Transoms are a band of windows located above the storefront window. These high windows allow daylight to reach farther into the commercial space. Often, the glass is

opaque and cut with prisms, further enhancing the amount of even light throughout the room.

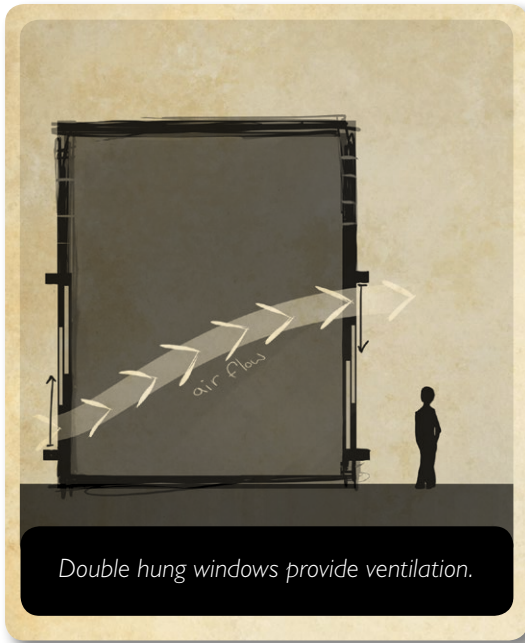
Like transoms, the tall windows allow more daylight to reach further into the building.

Double-hung windows also offer a unique means to ventilate and cool a room. When the upper sash of a window is pulled down, hot air is ventilated outside. Additional cooling is achieved by cross ventilation – raising the lower sash of a window on the opposite side of the room.

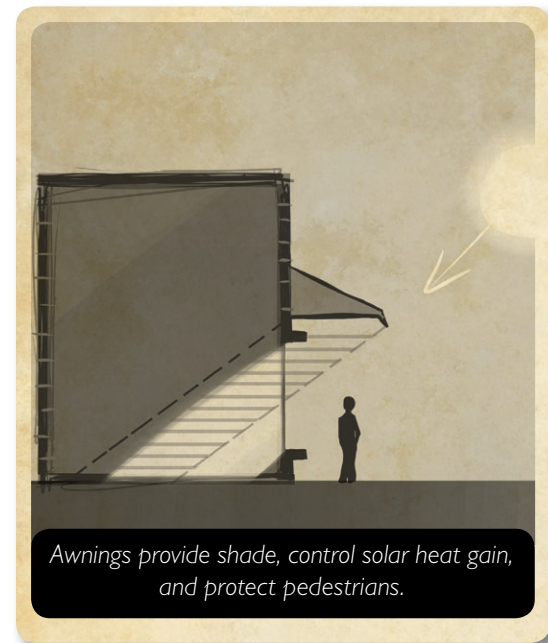
Fabric, retractable awnings serve a variety of functions. They provide a protected area for customers to stand while window-shopping. They also increase the opportunity to vary the intensity of natural light within the building. When lighting is harsh, an extended awning brings welcome relief. When the sky is overcast, a retracted awning allows every bit of light to fill the space.

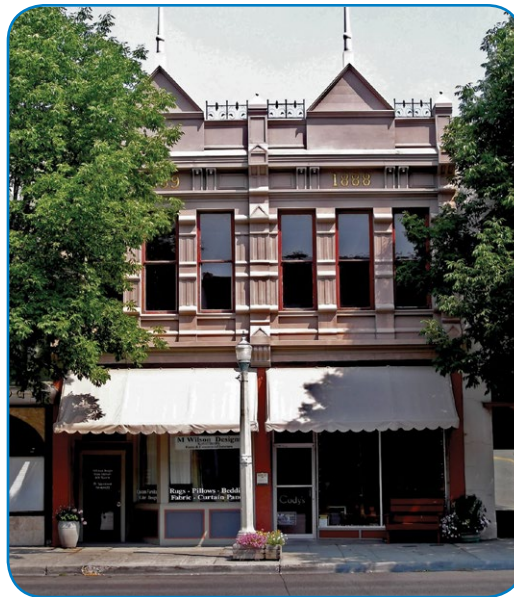
Awnings can also affect the temperature of the retail space. An extended awning will provide shade, and therefore lower temperatures in the summer. A retracted awning will allow solar gain into the building and raise interior temperatures in the winter.

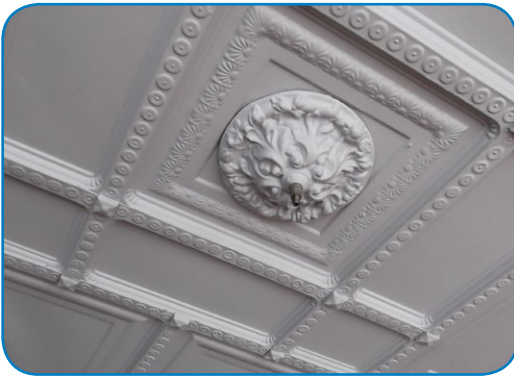
High ceilings enable taller windows to be installed, which in turn allows light to reach deeper into the structure. Higher ceilings also provide space for excess heat to rise before being flushed out of the building by vented skylights or transoms. When painted in light colors with a high gloss, ceilings can reflect light down to the workspace.

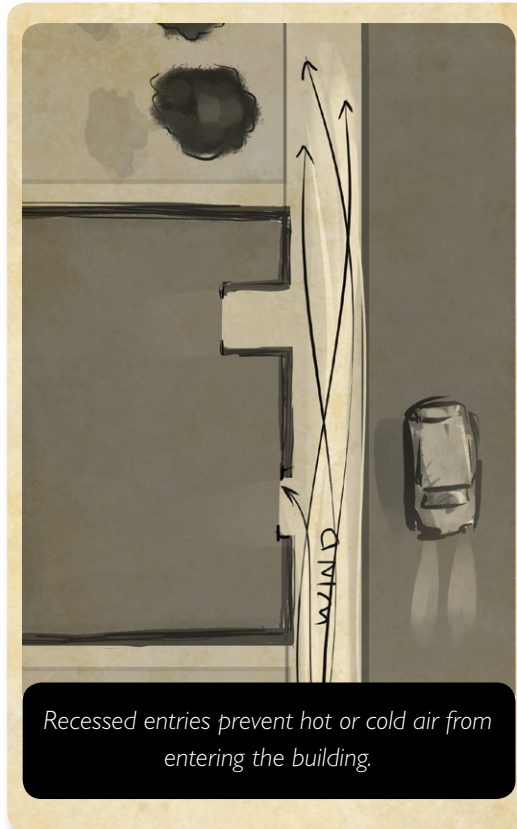
Recessed entries prevent hot or cold air from entering the building.

Set back from the sidewalk, these entries help prevent hot or cold air from rushing into the commercial space when the door is open.

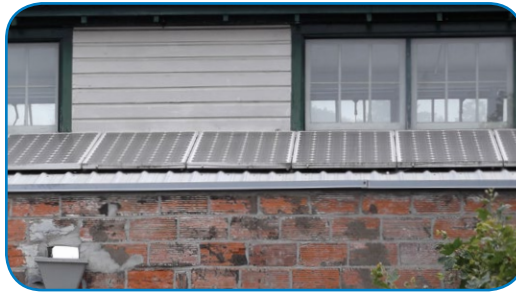
The simplest PV array consists of fixed, flat-plate, PV panels. Fixed arrays have several advantages: they lack moving parts, there is

virtually no need for extra equipment, and they are relatively lightweight. These features make them suitable for many locations, including flat commercial roofs.

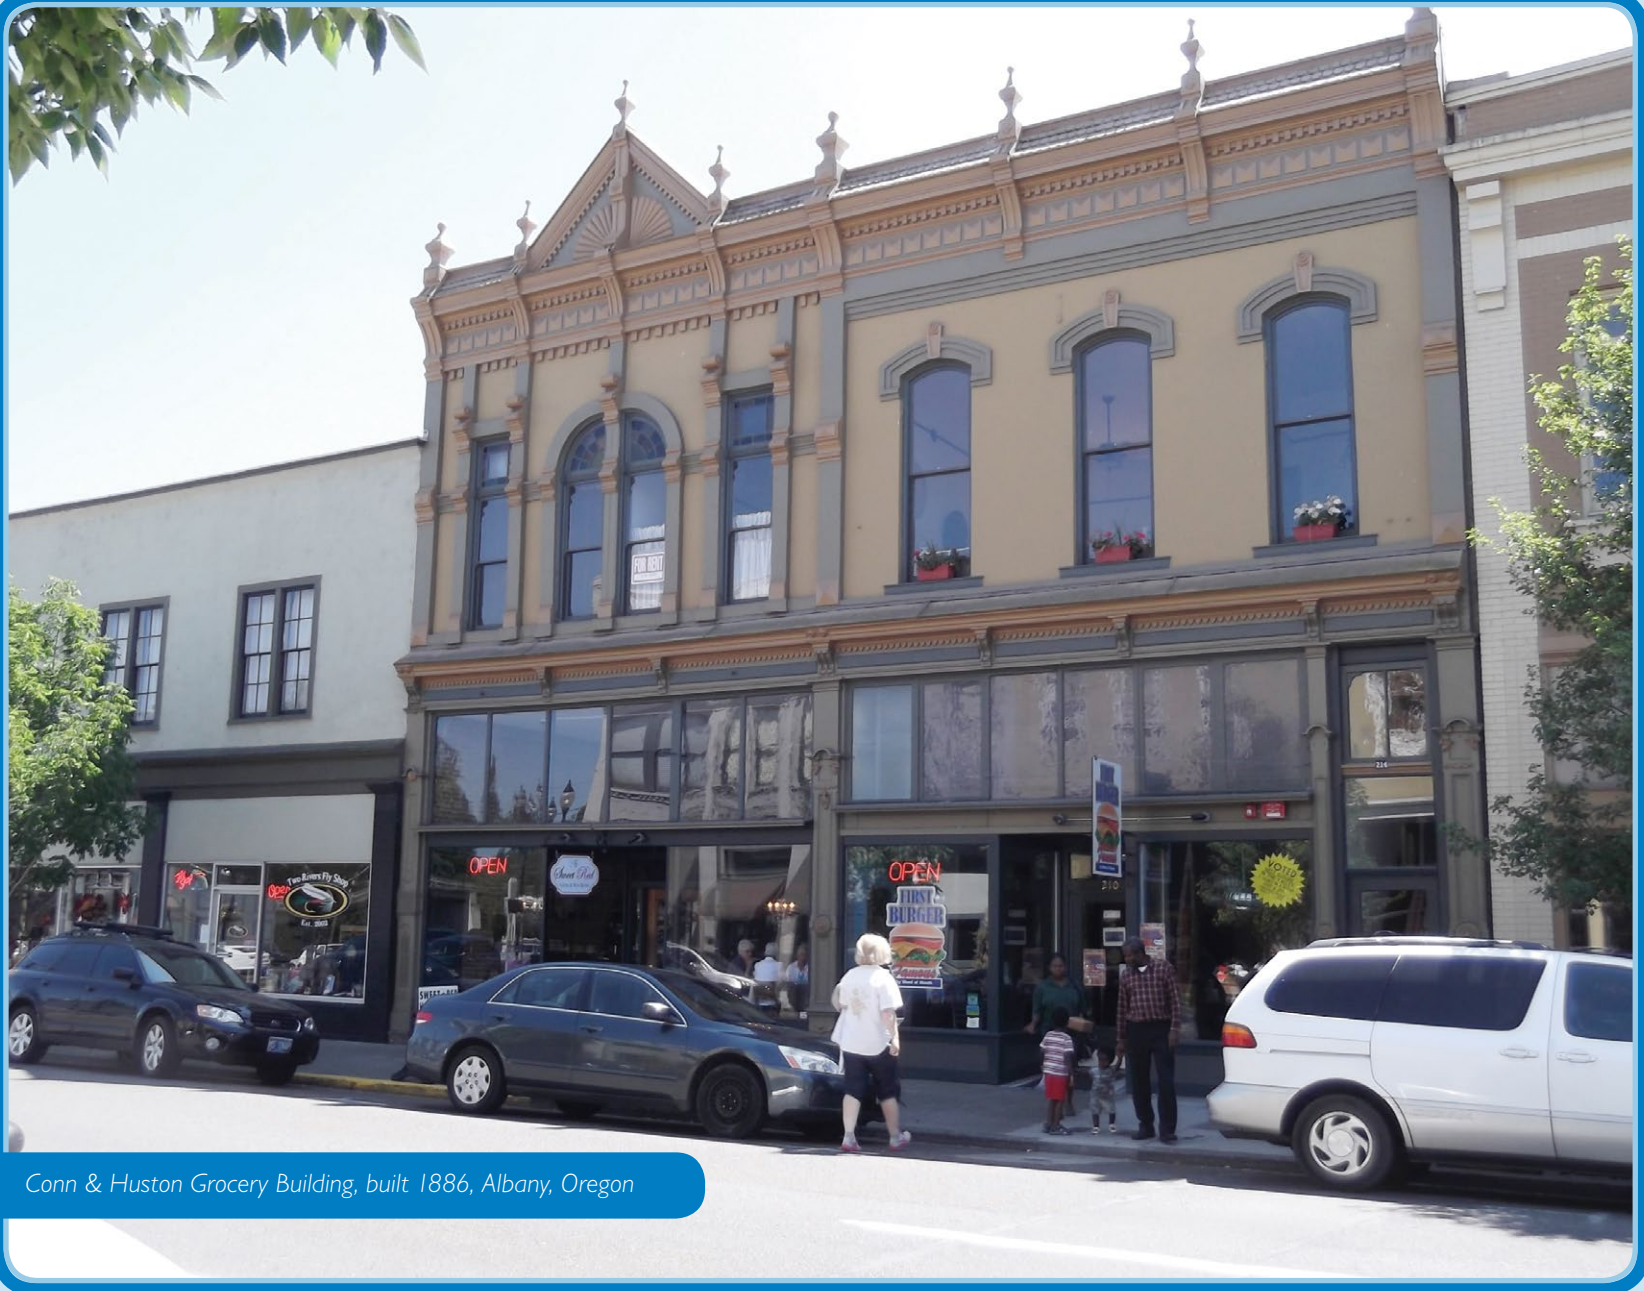
Conn & Huston Grocery Building, built 1886, Albany, Oregon

The two-story brick structure was constructed in two phases, one in 1886, the other in 1891. Its impressive façade features a cast iron cornice and pilasters. In addition to the grocery store, the structure also housed the Western Union Telegraph. By the time Throop purchased it in 2008, the building was on hard times: the front façade was buckling

and failing structurally; mortar was crumbling and in need of replacement; aluminum paneling covered transom windows; the second floor, a former rooming house, was under-utilized; windows were in need of repair.

After focusing on insulation, Throop turned his attention to windows. He repaired nearly every historic window in the building. He restored transom windows above the first floor storefront and cedar, double-hung windows on the second floor. Throop stripped the windows of paint, re-glazed them (replaced old putty), and replaced or re-hung the sash weights.

Today, the windows operate like the day they were installed, and they don’t leak air. The cost of rehabilitating the windows was a fraction of the cost to replace them and any energy efficiency lost through those single pane windows is counterbalanced by the low cost of their repair.

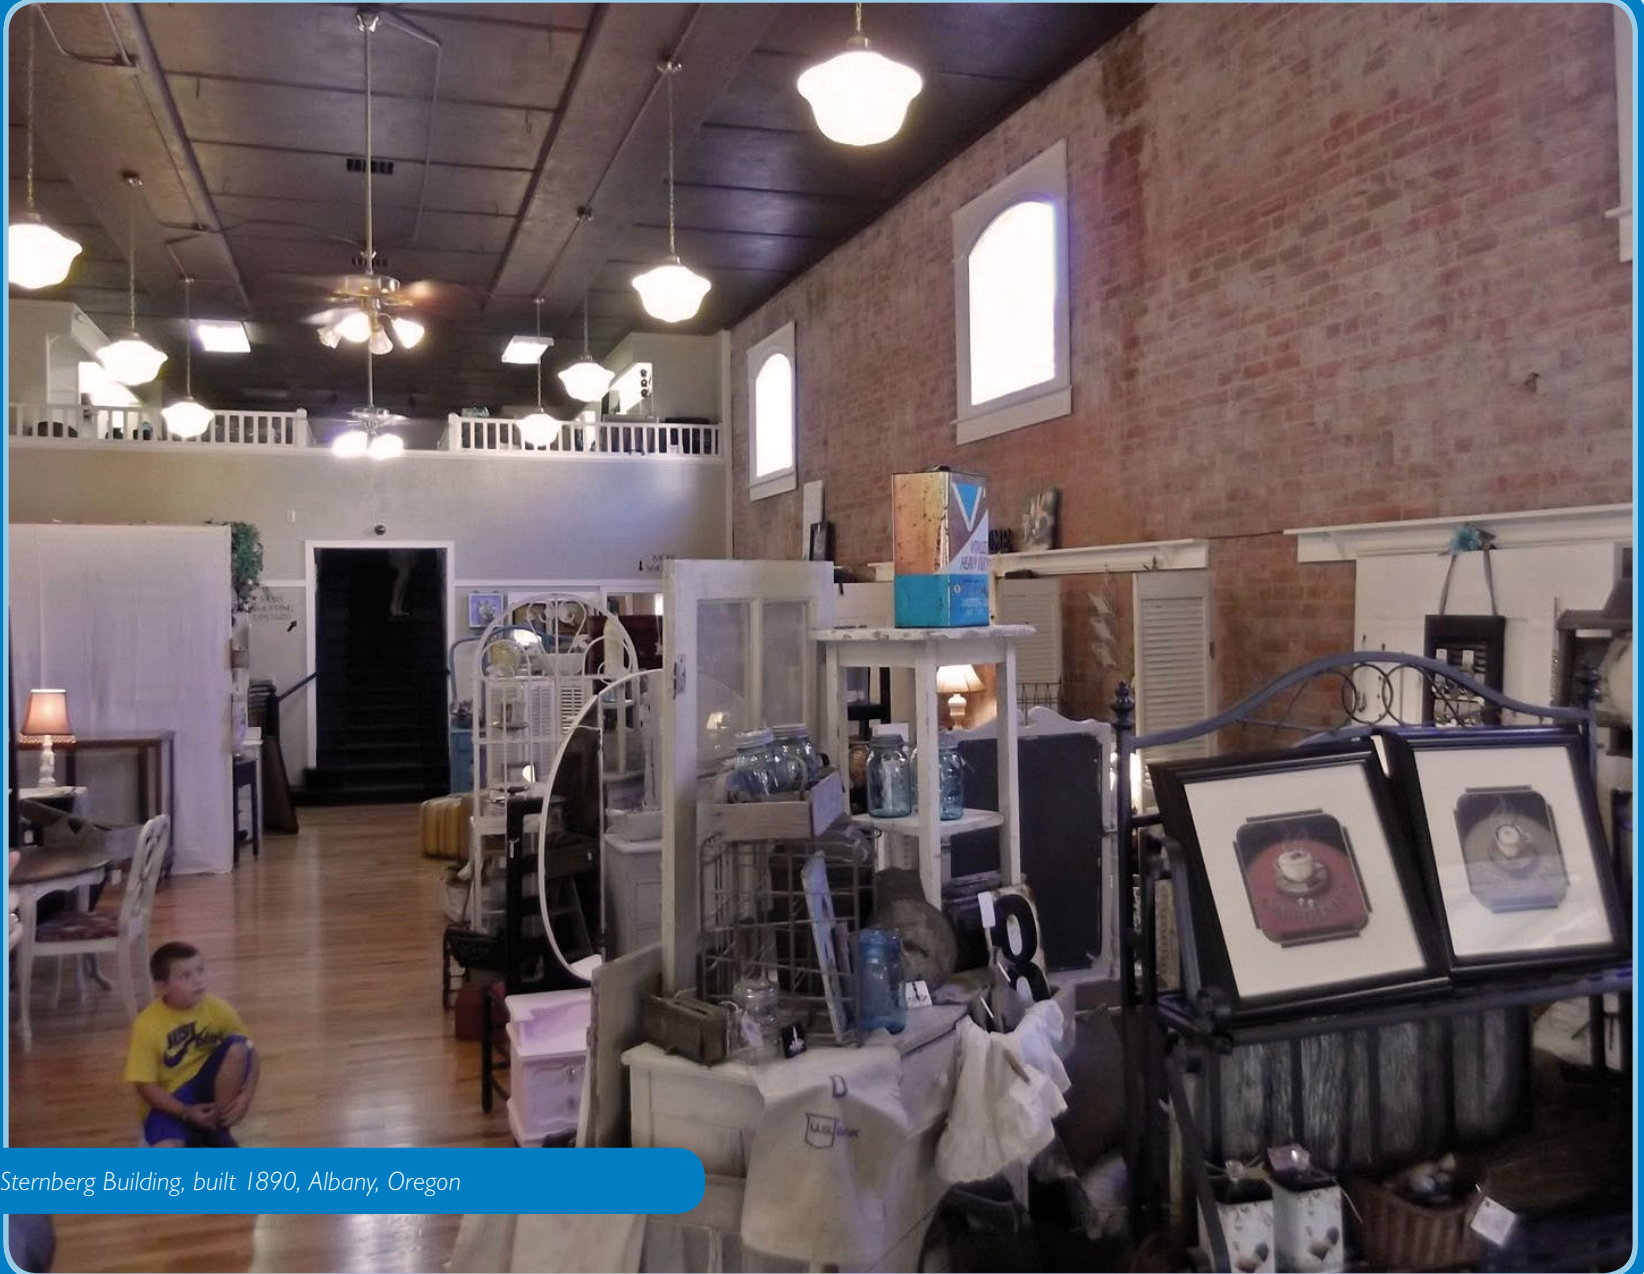
Sternberg Building, built 1890, Albany, Oregon

Constructed in 1890, the Sternberg Building housed both hardware and gentlemen’s clothing. Linda Poris began rehabilitating the building in 2009. Like many buildings, the Sternberg was remodeled in the 1950s or 1960s and covered with aluminum. A storefront, once flush with the sidewalk, was recessed to provide more cover.

seismic retrofit requirement, something Poris was not able to undertake. Instead, they removed aluminum paneling from the front, retained the brick façade and approached the renovation with a “no harm” approach.

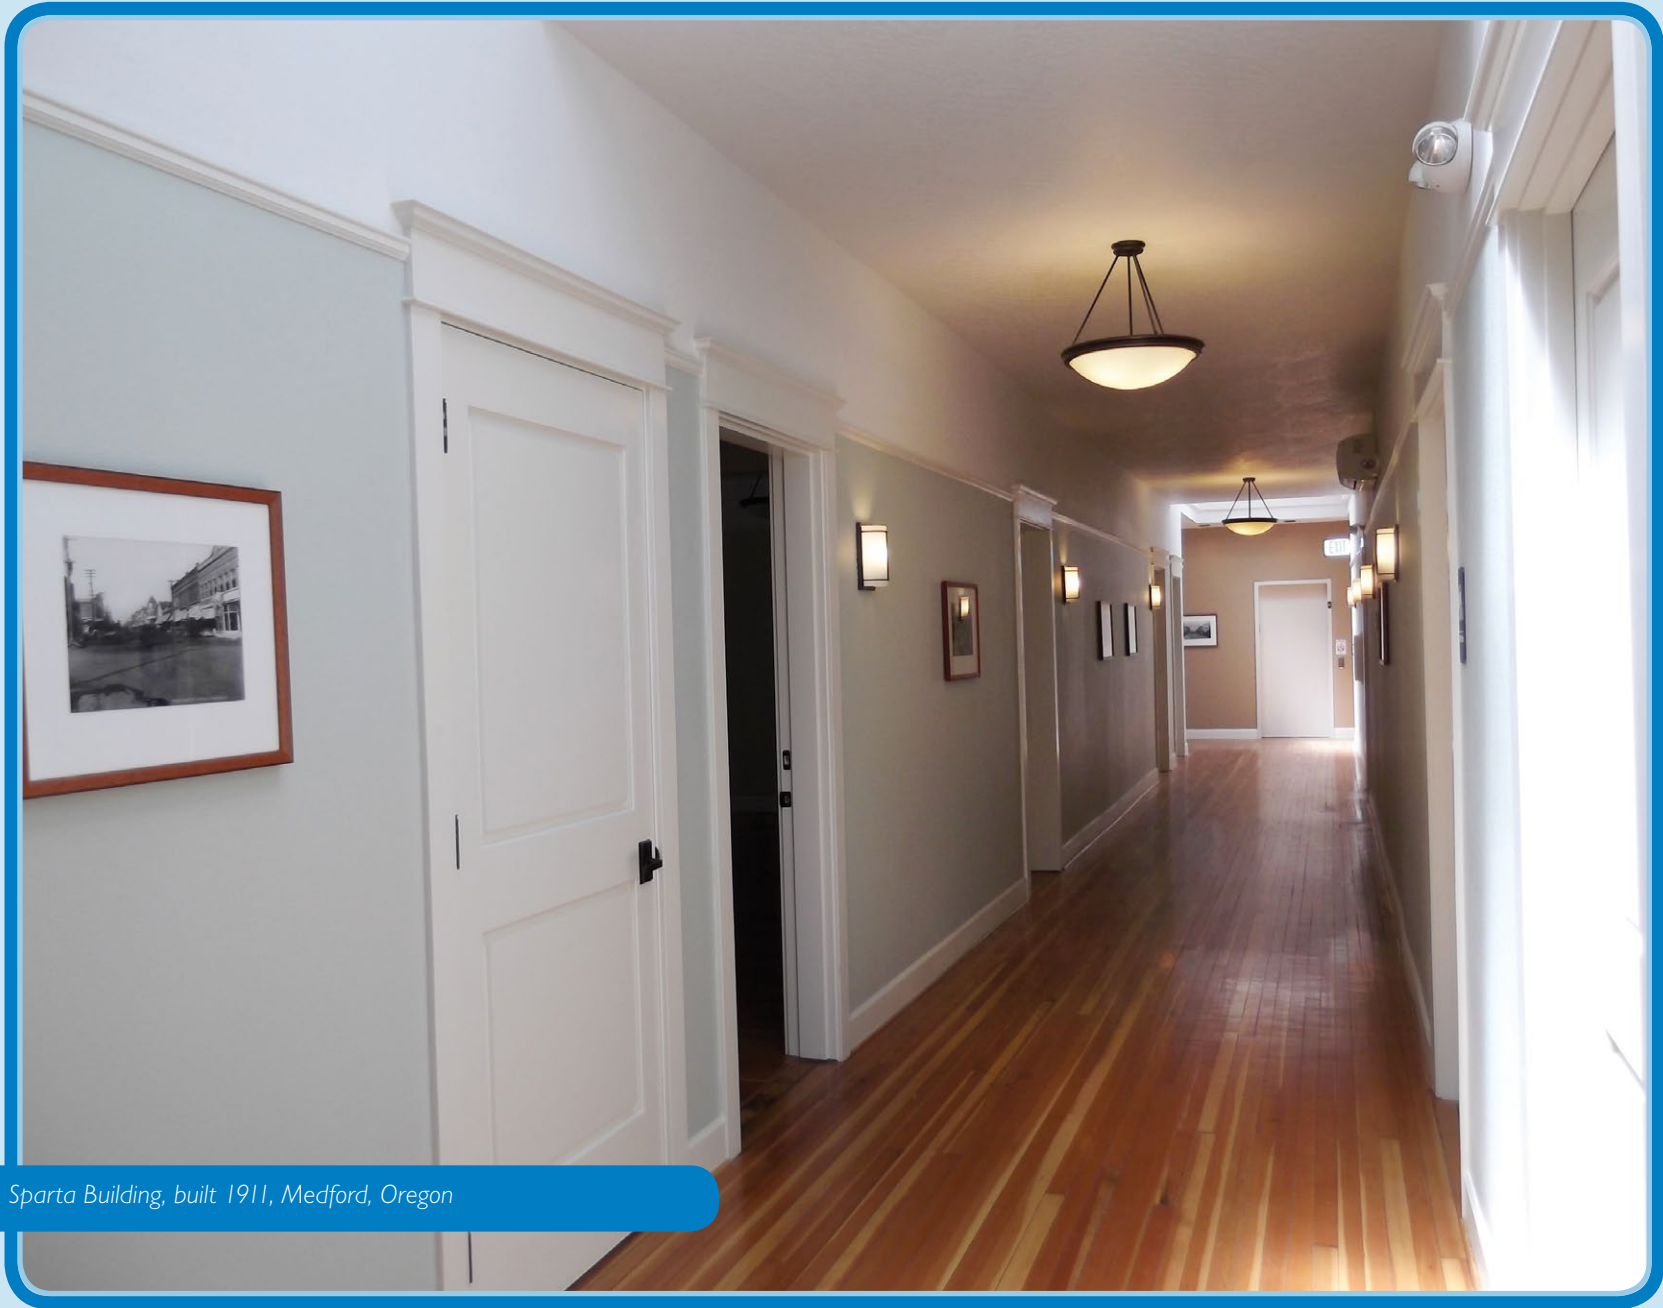
Sparta Building, built 1911, Medford, Oregon

Constructed in 1911, the Sparta Building housed Medford’s first Ford auto dealership. Today, the building is under renovation.

- Seismically upgraded building.
- Reconstructed front entry.
- Weather-stripped and repaired original windows.
- Restored skylights.
- Installed light sensors and compact fluorescent lamps.
- Installed low-flow fixtures in ADA-compliant restrooms.
- Placed insulation in ceiling.
- Installed high efficiency ductless heat pump system.

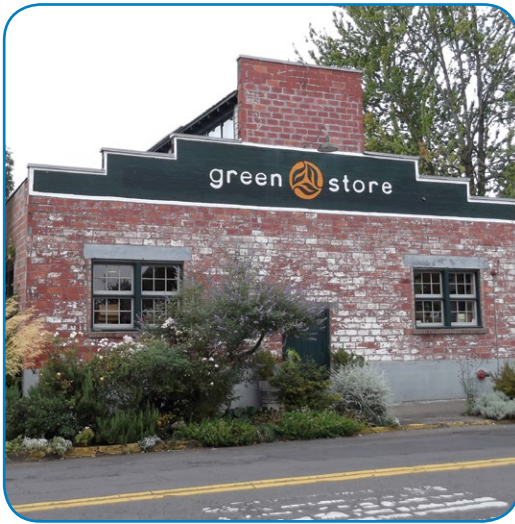
The building’s daylighting and ventilation functioned beautifully.

The Pacific Cooperative Poultry Producers’ Egg-Taking Station was constructed in 1928 from concrete and hollow tile. Clerestory windows stretched the building’s entire length and dominated its interior spaces.
